Safety Alert Number: 251

SAFETY ALERT

Category: Injury - Safely loading boom lifts onto tilt trays

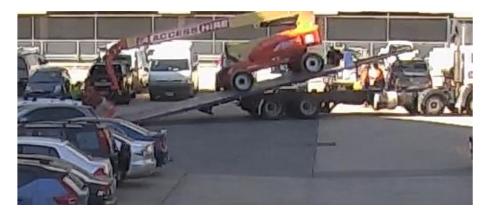
Image 1: Depicts the point of contact between the tray and the basket with brake wheels slightly raised off the truck tray.

- When loading boom lifts onto tilt tray trucks always ensure the winch cable is connected to the machine and the boom lift is winch and driven onto the tray.
- When stowing the boom basket for transport always conduct the activity from the ground controls after the machine has been restrained.
- Ensure appropriate PPE including a full body harness are worn by transport operators.
- Ensure transport operators are trained and competent to undertake activities.
- Ensure trucks, winches and machines are maintained on a regular basis as per manufacturers guidelines.

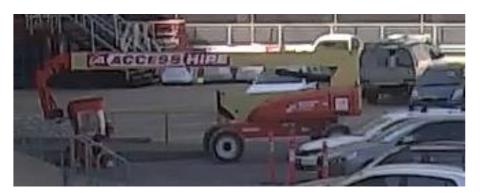
Image 4: Depicts the machine during its uncontrolled movement with the basket being dragged by the jib of the machine along the loading dock hardstand area.
